FLOOD PLAIN MANAGEMENT STUDY

KAYENTA COMMUNITY

Navajo County, Arizona

DECEMBER 1988

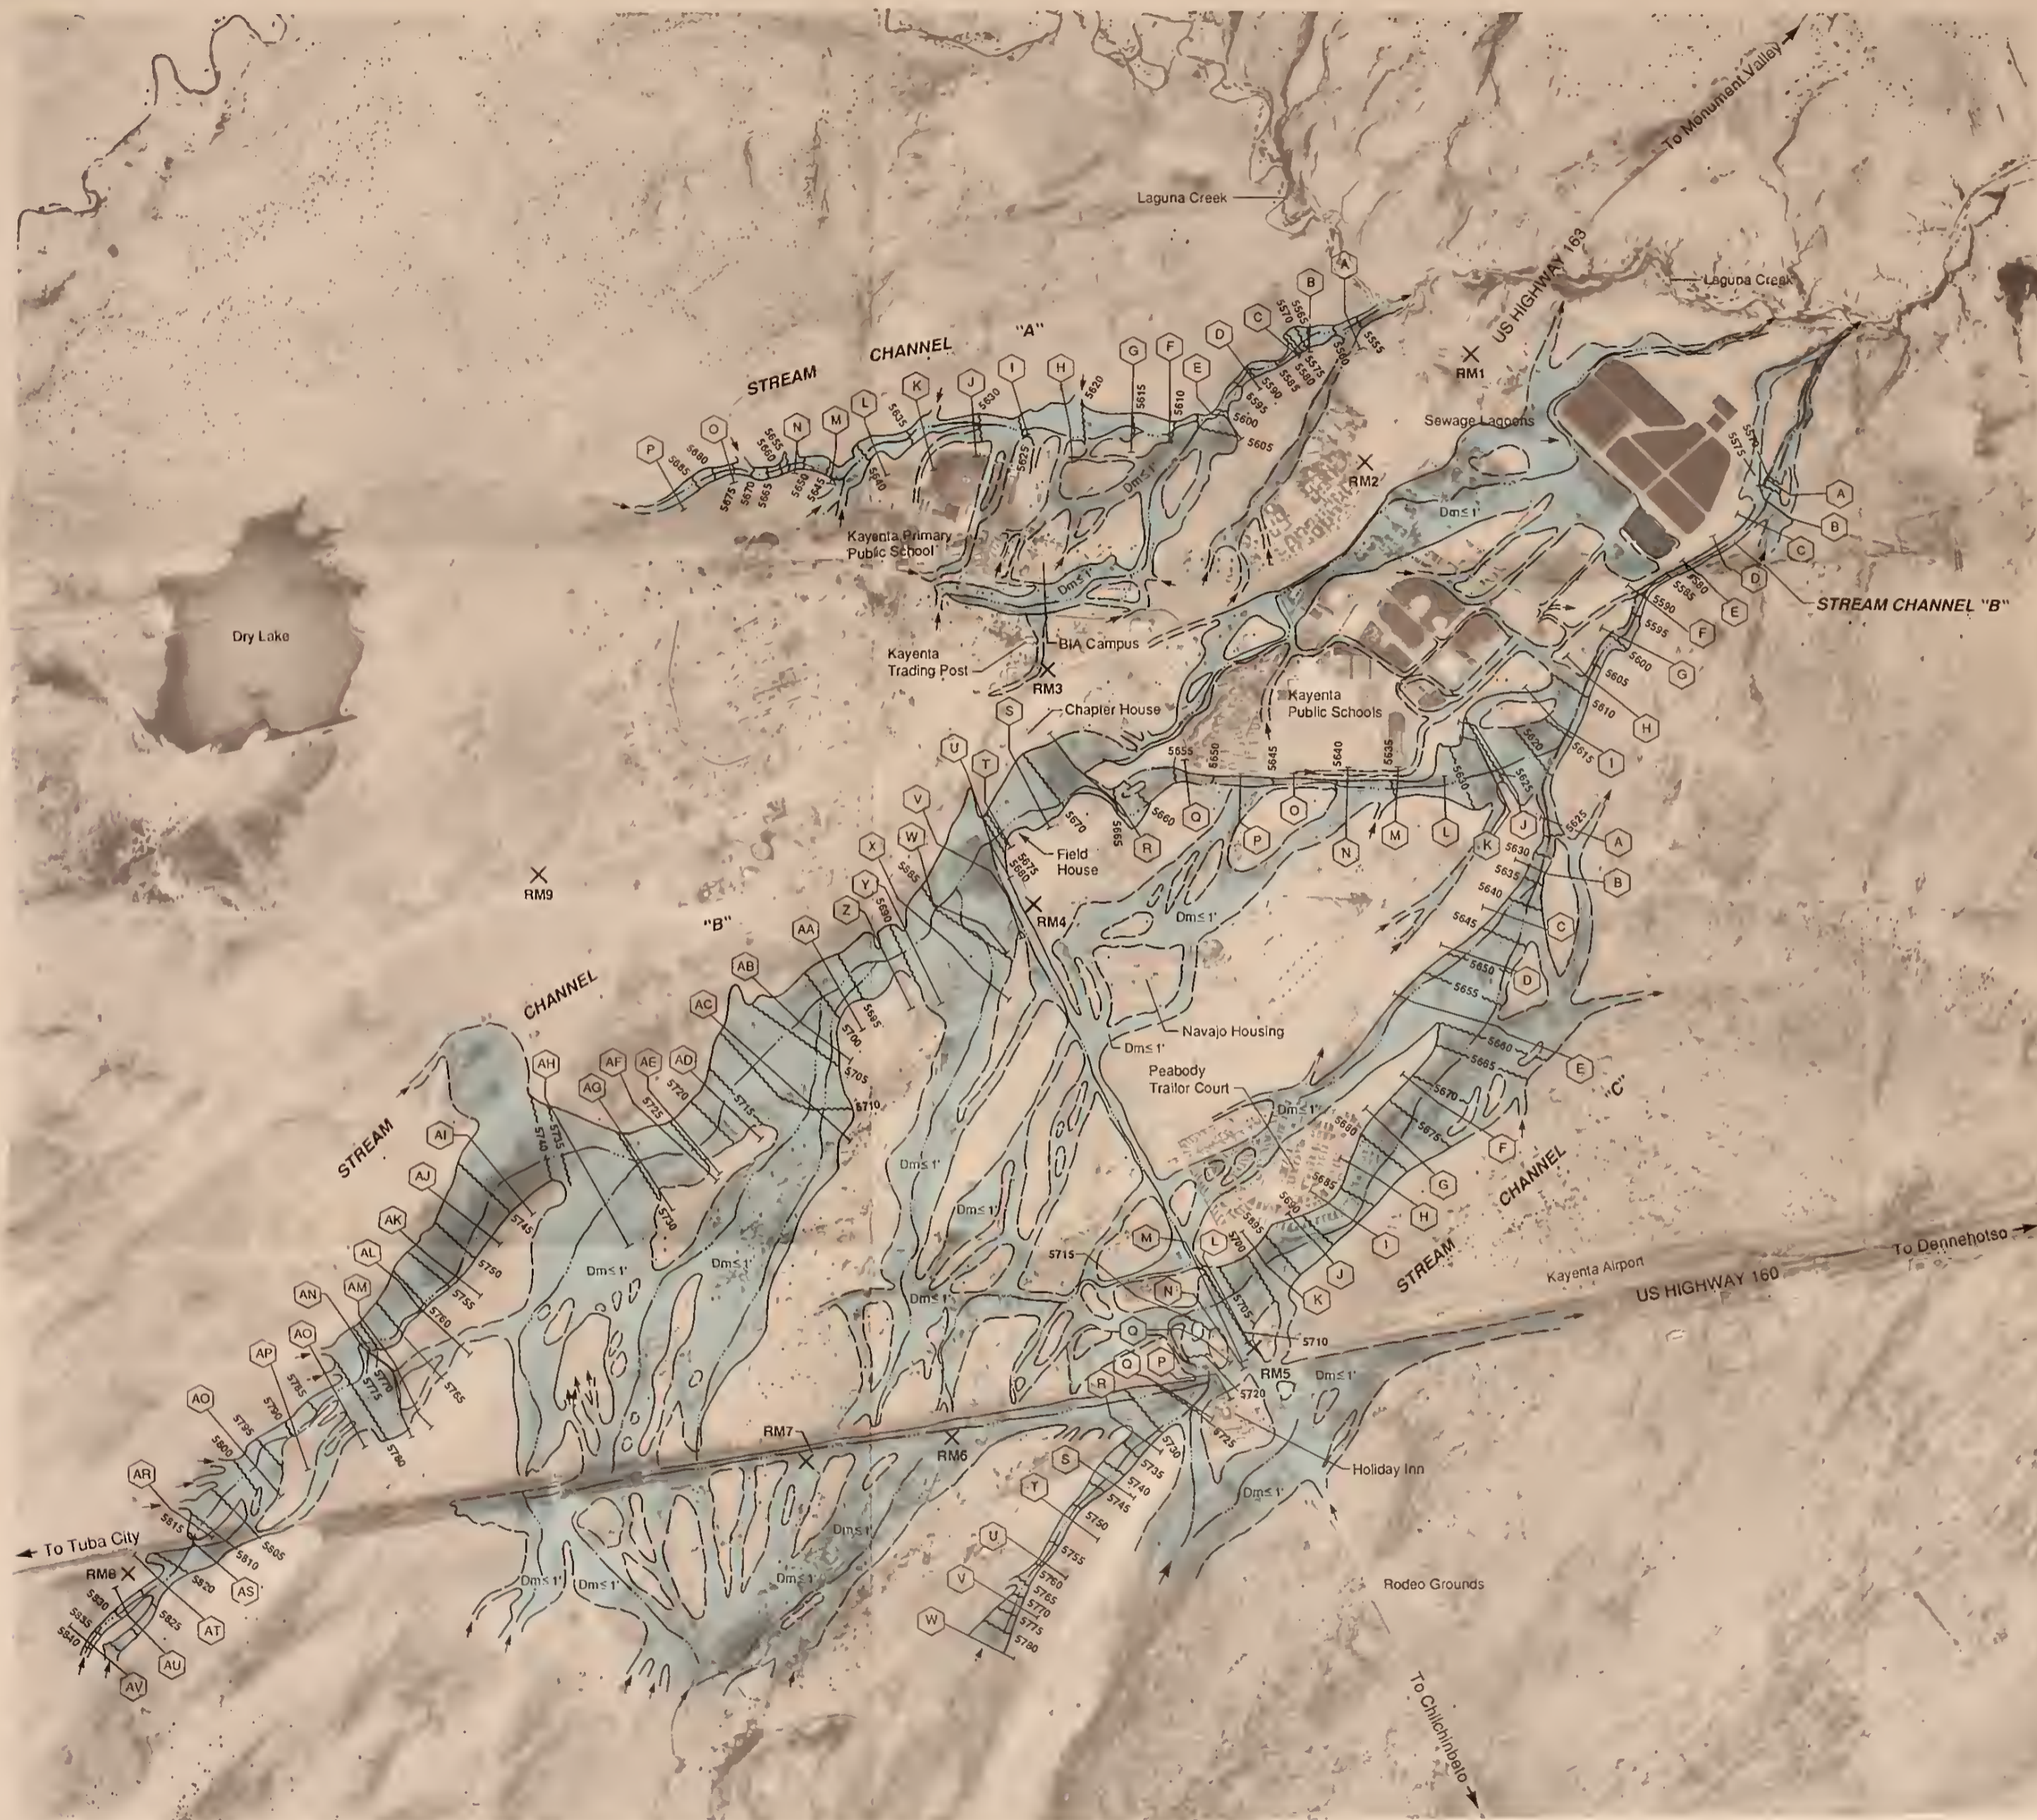
**FLOOD HAZARD AREA
KAYENTA
FLOOD PLAIN MANAGEMENT STUDY
NAVAJO COUNTY, ARIZONA**

The 100-year flood plain, within the study area, inundates about 960 acres. This size of flood will cover about 70 acres of urban land, 110 acres of cropland and 780 acres of rangeland. Refer to the Flood Hazard Map in the back of this report.
